A PRELIMINARY COMMENT ON

BETHANIE HALL

HONG KONG

BETHANIE MONASTERY: A PRELIMINARY COMMENT

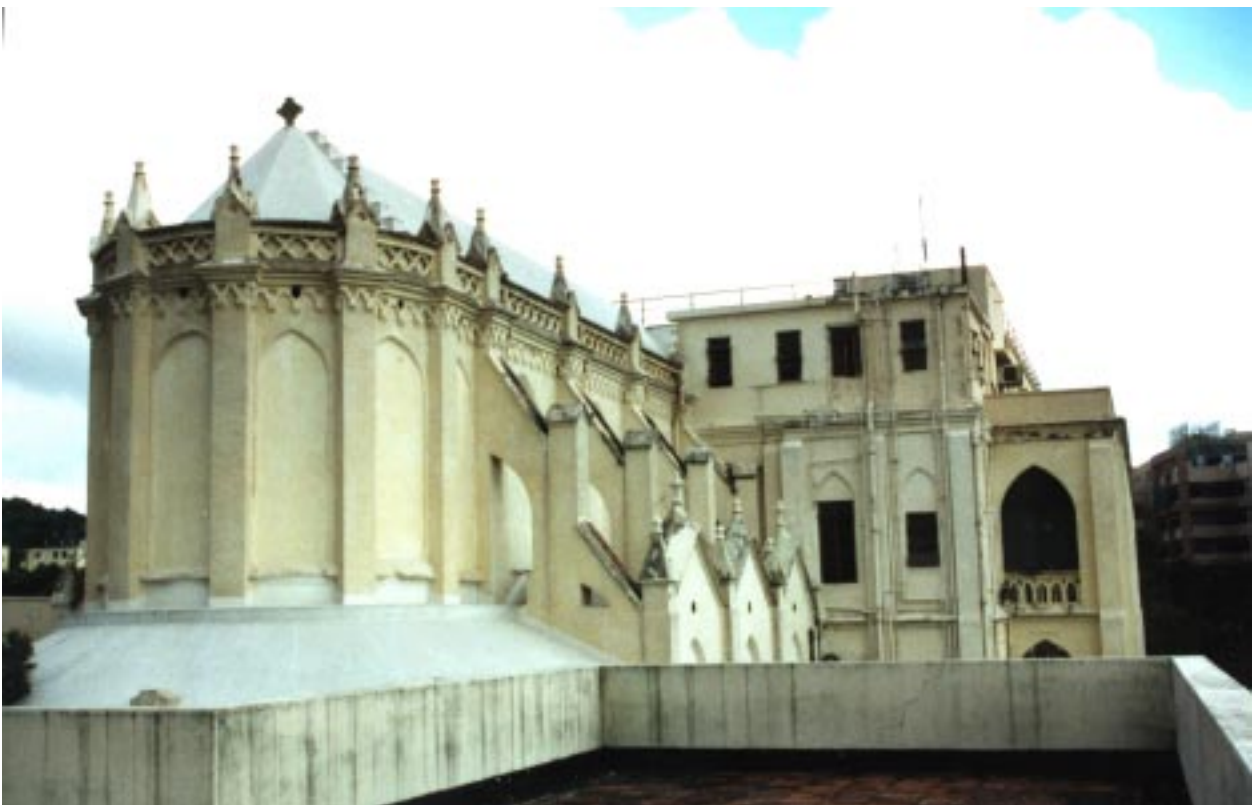
The narrow chapel with wider 'nave' beyond, derived from a medieval hospital plan

The design of Béthanie Hall is based on gothic architecture of the 13th century and the plan is clearly derived from the design of hospitals of that period, which were closely related to the plans of churches. The chapel is in the position of a chancel, while the 'nave' provided accommodation for 'patients' or the elderly. The most perfectly preserved hospital of this design is the 13th-century St Mary's Hospital at Chichester (UK). The chapel has a more complex design than would be likely in a medieval hospital, however, because of the need for individual secondary altars at which the priests living in Béthanie could each say mass – there are side chapels for six such altars. In a medieval hospital, the area of the 'nave' would have remained open, with the beds occupying private cubicles at most defined by wooden screens. At Béthanie Hall, in contrast, the accommodation was designed to reflect the comforts required by priests in the 19th century, with the 'nave' divided into eleven private rooms on each floor, some heated by fireplaces, reached by a central corridor on each floor which provided a view into the chapel. The use of a double-storeyed plan for the 'nave' is a logical progression when the space has been divided up into separate rooms, rather than retaining the open plan of its medieval prototype.

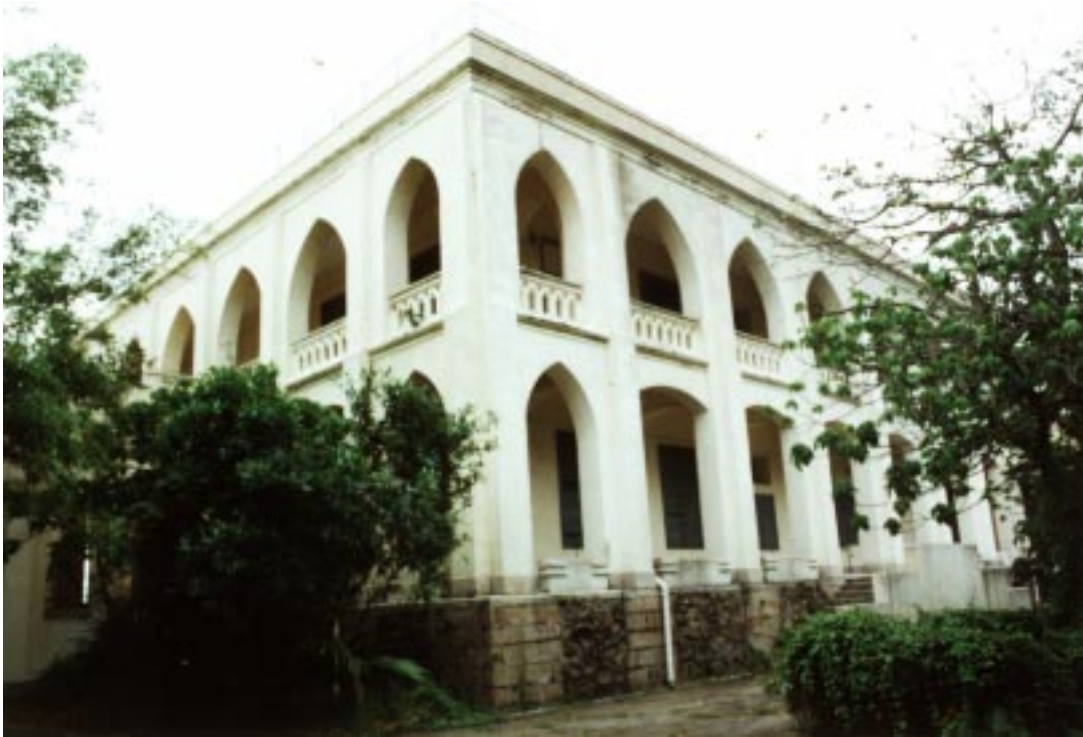
Because of the tropical climate, the 'nave' is surrounded by a two-storey arcade to provide shade

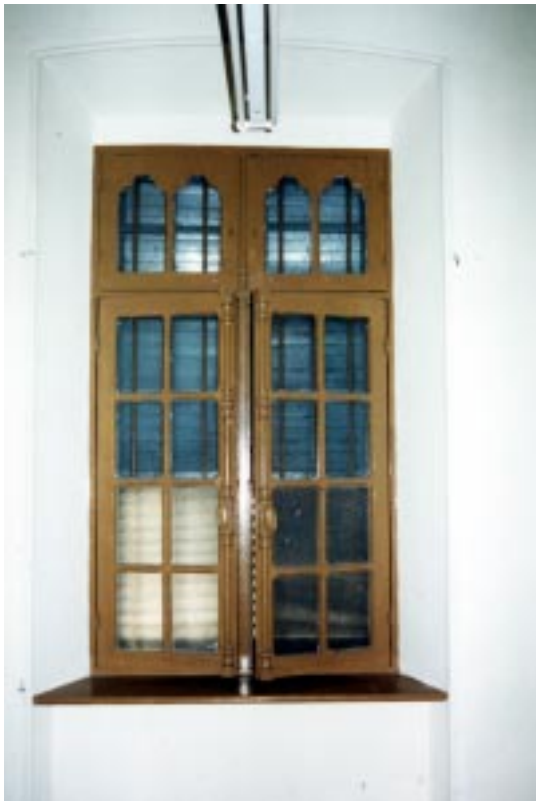
The windows have catches probably imported from France

available. The form of the windows is entirely French and the window catches appear to French in origin. The encaustic floor tiles may also come from the same source, as they do not appear to be Minton tiles from Staffordshire.²

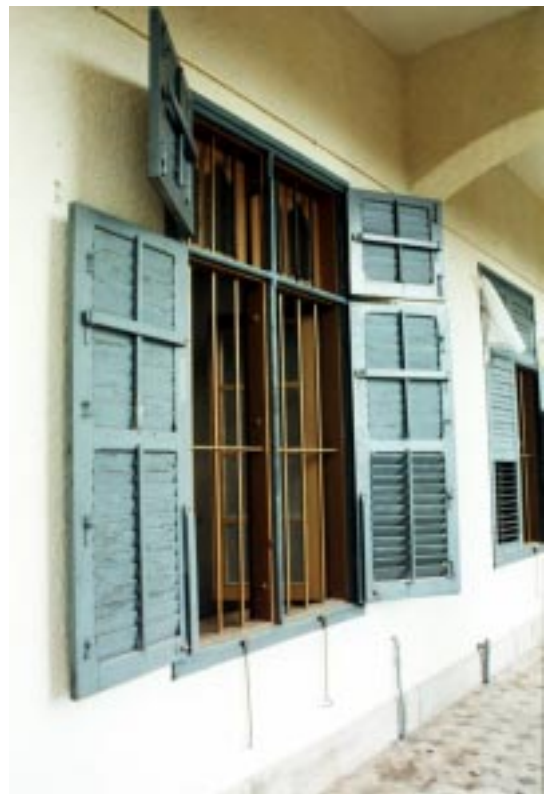
Window shutters of French design

ditions and alterations to the lower storeys, however, are of much better quality and should be retained, as should original detailing such as the doors, windows and shutters.

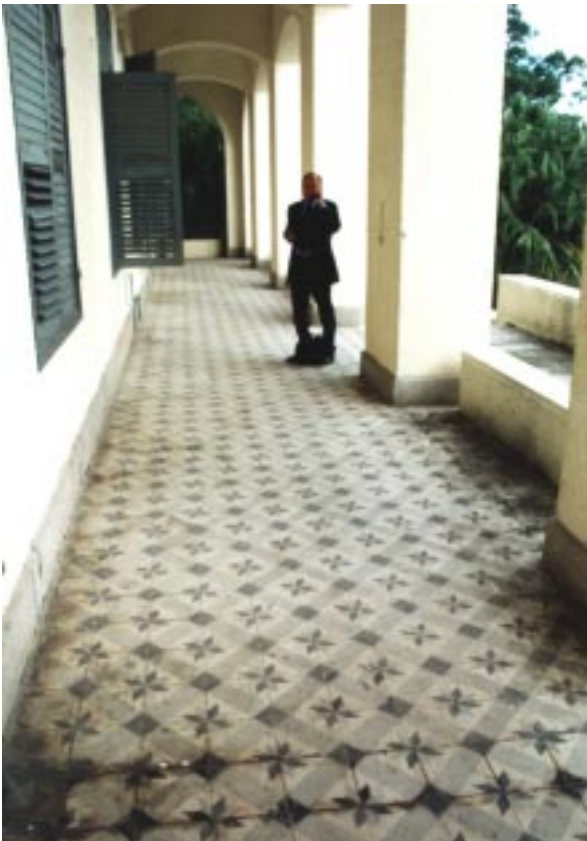
Encaustic floor tiles probably imported from France

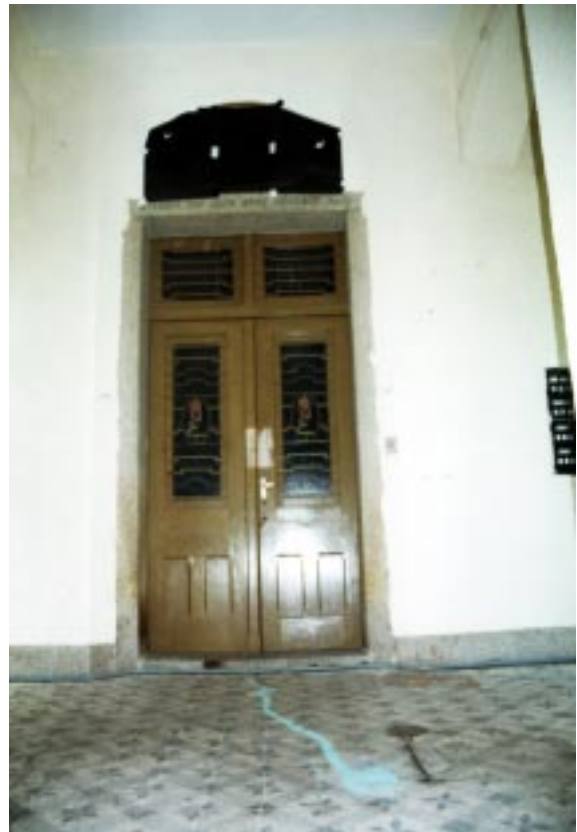
Art deco door - a 20th-century alteration

The main building has what appears to be two phases of alteration in the 20th century. There are some good-quality art deco alterations, such as the main door leading into the ground-floor corridor from the port cochère, and the window grills in the flanking pavilions are also of good-quality art deco design. The added top storey to the 'nave', however, has detailing of an inferior quality and what are probably standard Crittall steel windows, im-

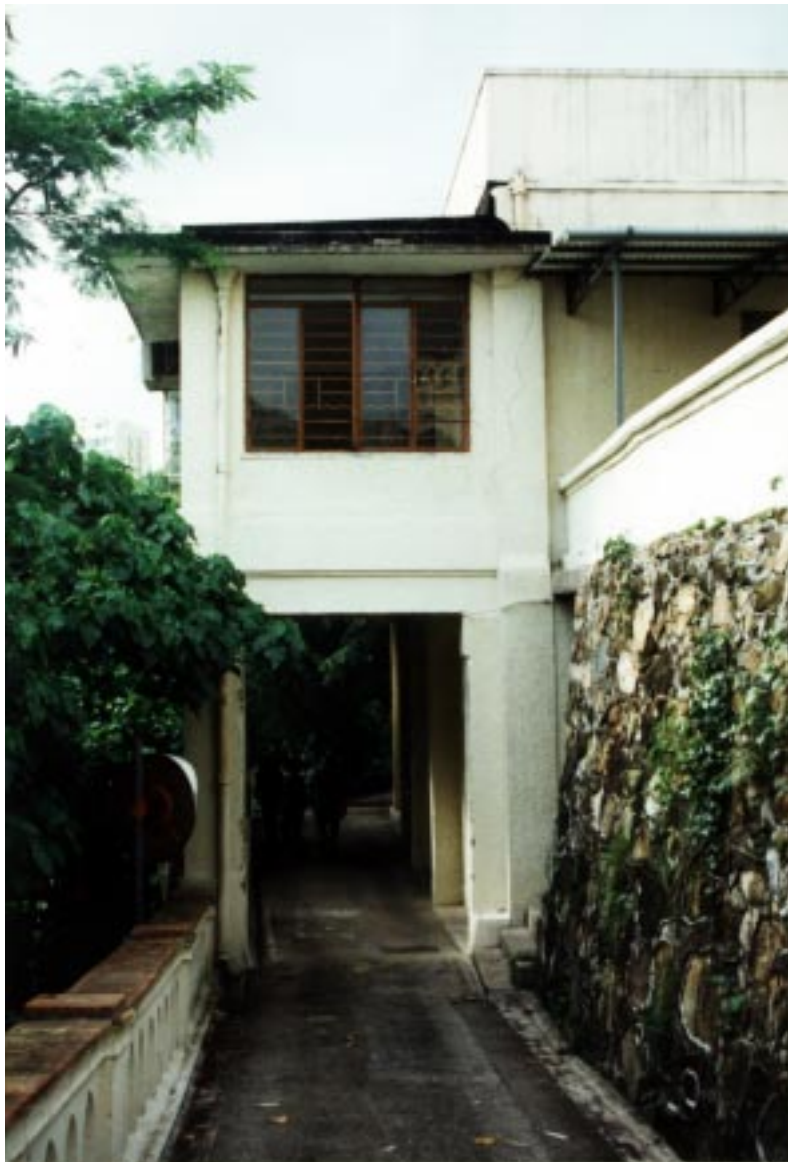
The two flanking pavilions are shown on the early photograph but their present detailing belongs entirely to the 20th century. Further investigation will no doubt show whether they were entirely rebuilt or represent remodellings of the 19th-century originals.

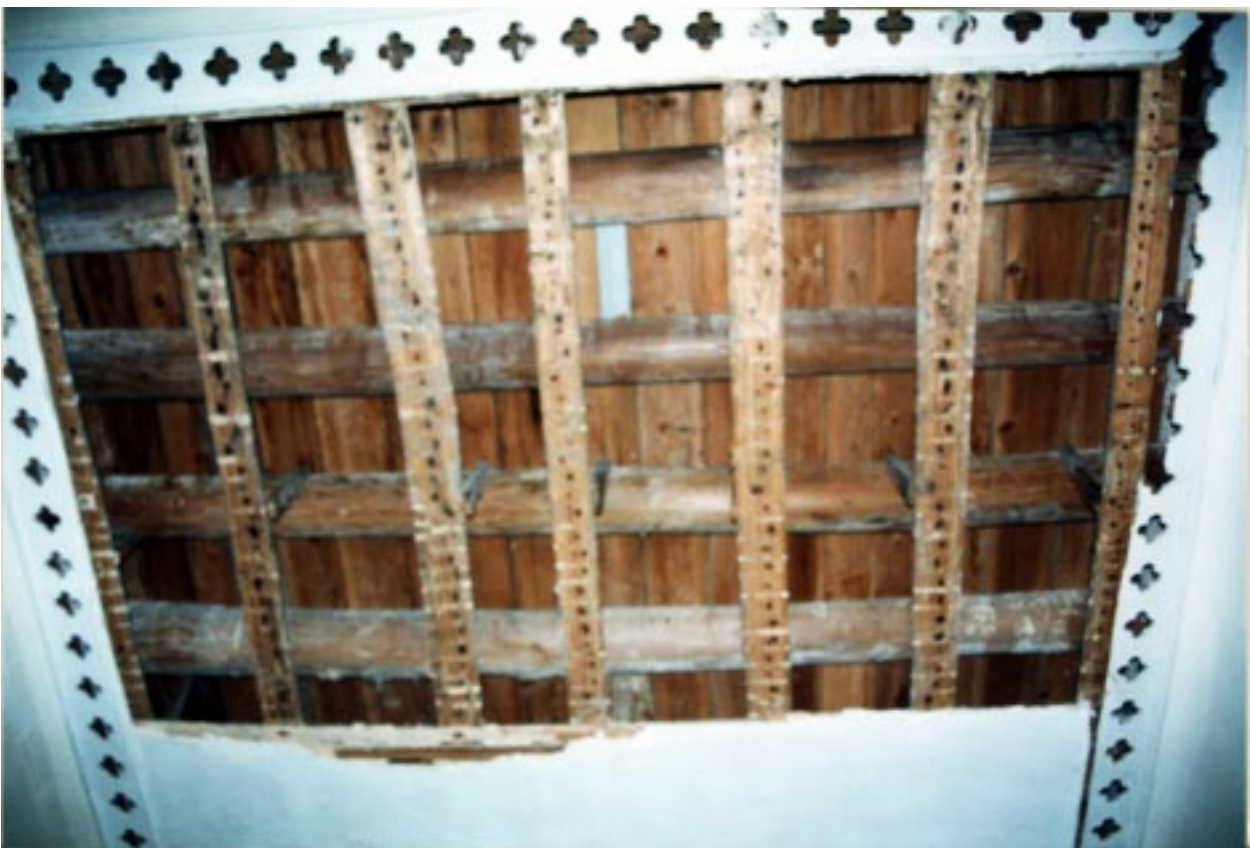
The section of the first floor of the 'nave' which has been exposed seems to be in good condition and utilises joists of log form, derived from comparatively small trees. Floor joists which require additional performance for a new use can be strengthened by the insertion of flitch plates, but this requires evaluation by a specialist structural engineer able to calculate timber structures. However, the comparatively small spans in the main part of

Original floorframe over the central corridor of the 'nave'

the building, in which the space is divided up by numerous load-bearing walls, may mean there is no problem.

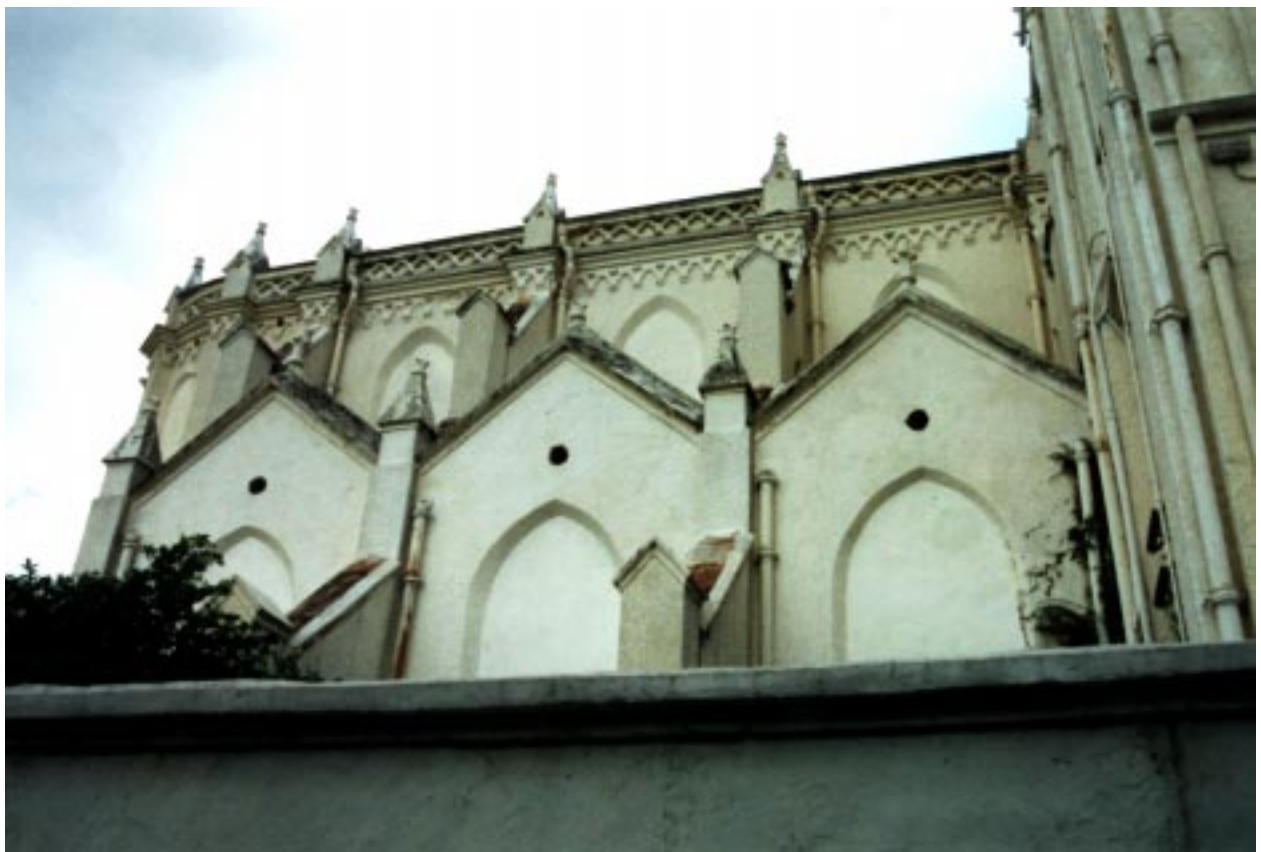
The windows of the chapel have mostly been blocked by masonry. The reinsertion of leaded lights would not be unduly expensive, but it may be that the new use, perhaps as a concert hall, may require the retention of these window blockings.

Blocked windows which lit the altars of the subsidiary chapels
